# City of Arvada

## Planning Commission Agenda

A. Major Comprehensive Plan Amendment for 6800 Kilmer RV Storage, a 14.01 acre parcel, addressed as 6800 Kilmer St. and located at the terminus of West 68<sup>th</sup> Avenue just west of Indiana Street.

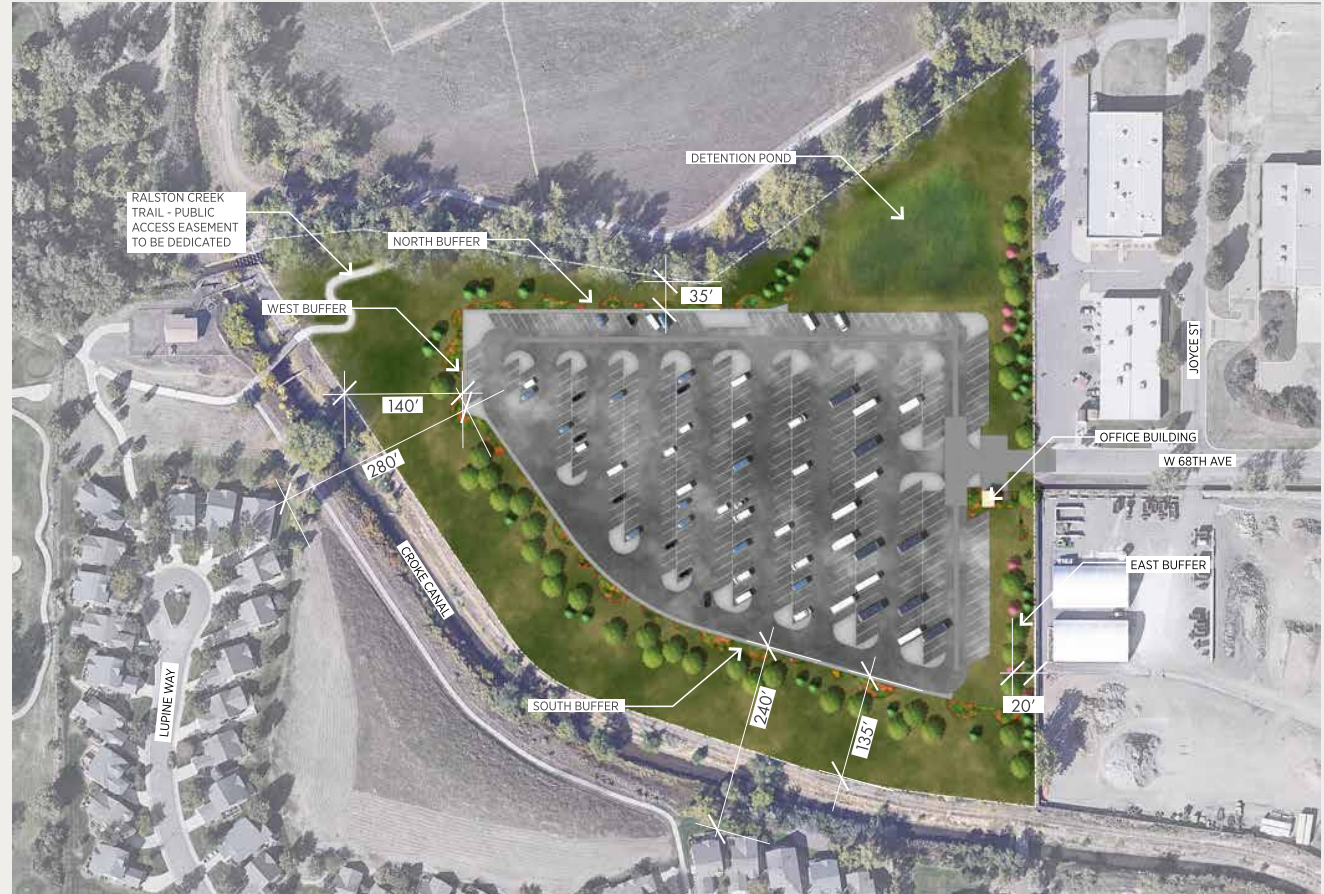
- Lot size: 14 ac
- RV parking spaces: 355
- Office building: 240 SF
- Detention pond: 36,025 SF
- Landscaping: 53%
  - Includes minimum 240' buffer from fenceline to RN-4 zoning

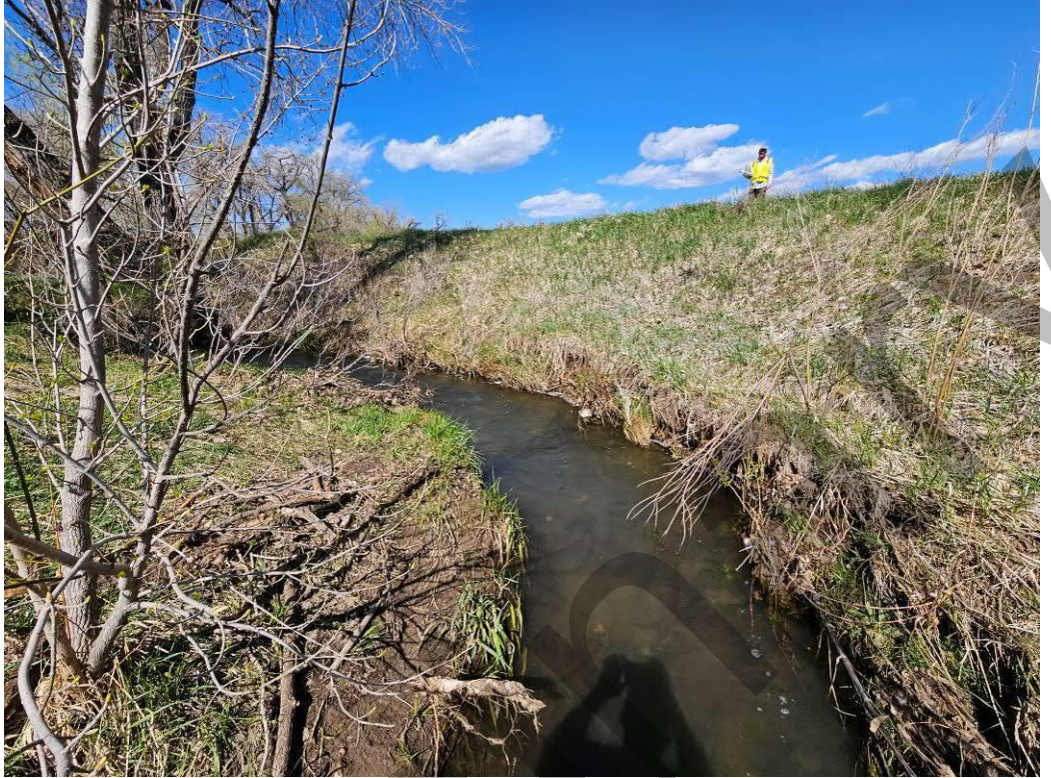
| <b>Photo 21</b> | |

| Description:<br><br>Viewing failing previous bank stabilization efforts due to vertical channel incision and undercutting the bank stabilization from channel confinement. | |
